# Inspection Report

## SAMPLE REPORT

123 Main Street  
Anytown NH 01234

At the request of John Doe, Facilities Manager, Russell Inspection Services conducted a property condition assessment with Thermal Imaging for the warehouse located at 123 Main Street, Anytown NH. The purpose of our survey was to observe specific aspects of the property and to list our observations of the general condition of the property, including a limited Infrared Thermal Imaging survey.

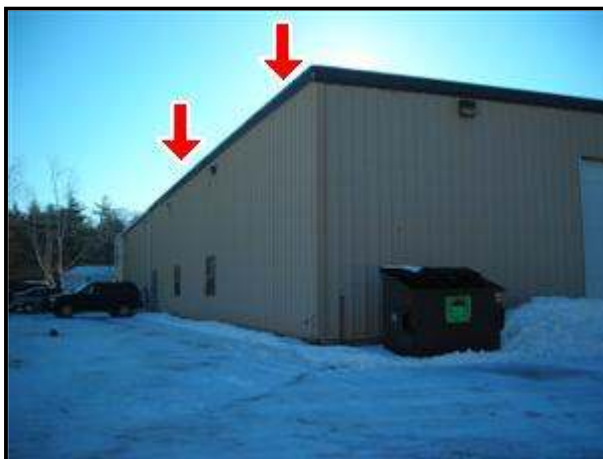
**1.2** The gutters and downspouts are limited to the side entry only. I recommend commercial size gutters and downspouts be installed on the entire perimeter to divert water away from the building.

1.2 Picture 1 Install gutters and downspouts.

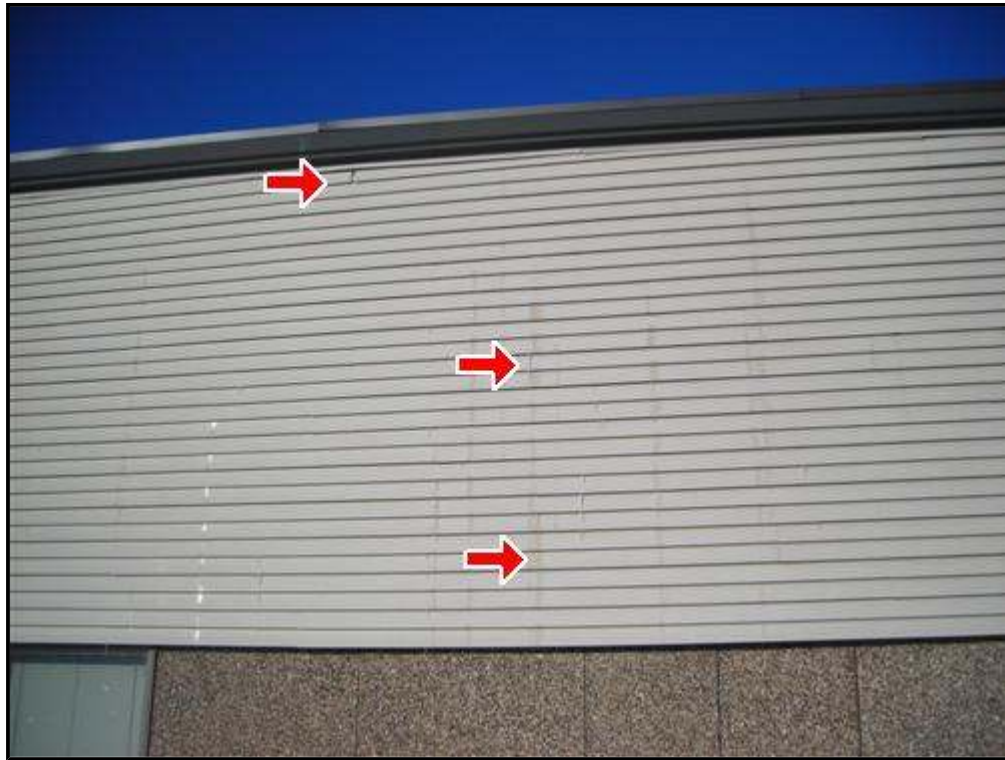
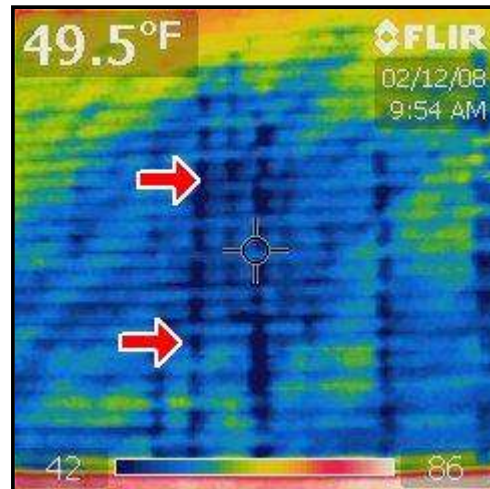
**2.0** There is evidence of moisture intrusion behind the vinyl siding. This siding has areas where minimal overlap techniques were used and therefore it has contracted exposing the vapor barrier. Repair/upgrade of the vinyl siding should be budgeted in the maintenance plan.

2.0 Picture 1 Moisture intrusion behind siding.

2.0 Picture 3 Moisture intrusion behind siding.

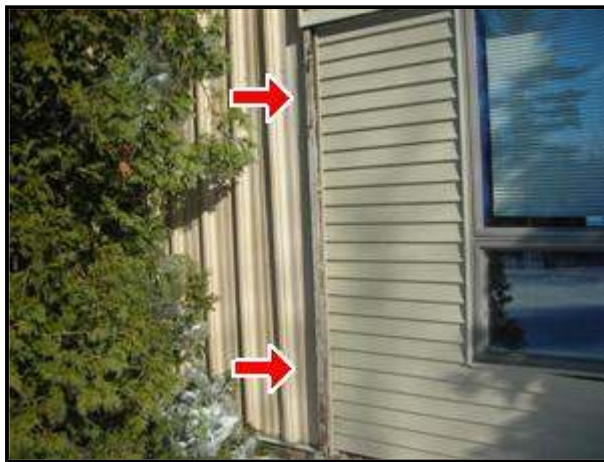
The connection between the vinyl and steel siding consist of a wood trim board. This trim board is deteriorated and should be replaced.

2.0 Picture 2 Trim board.

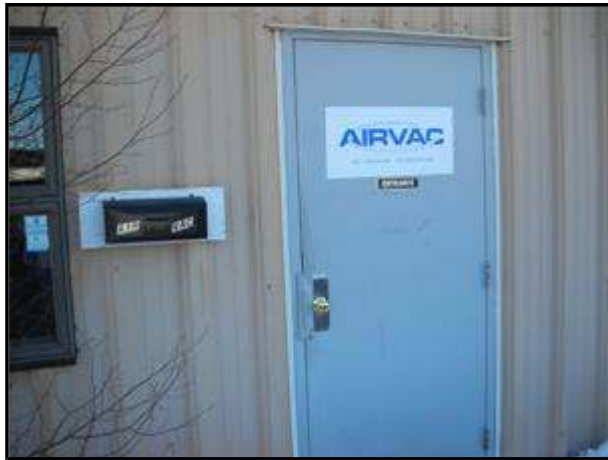
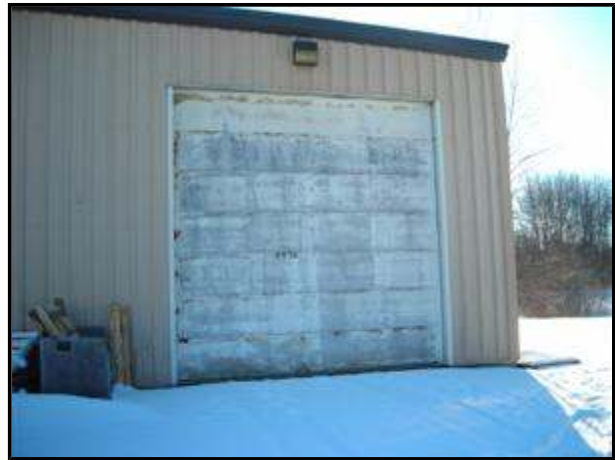
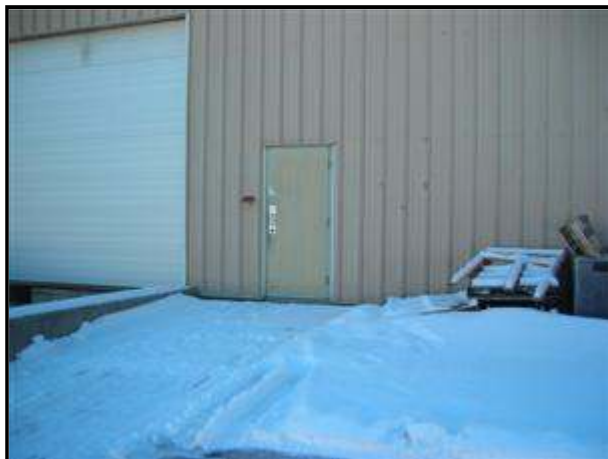
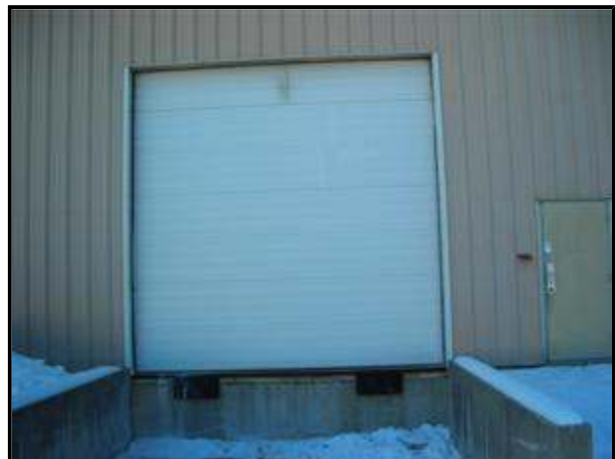
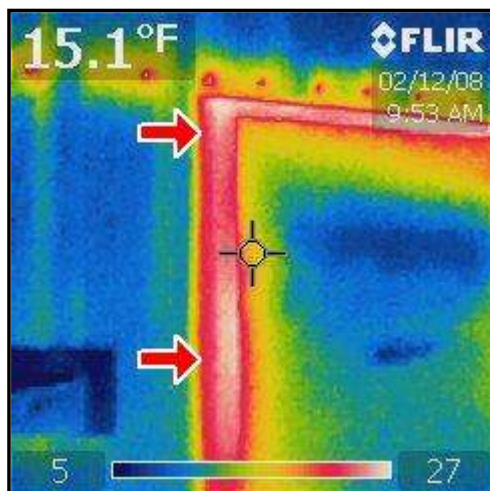
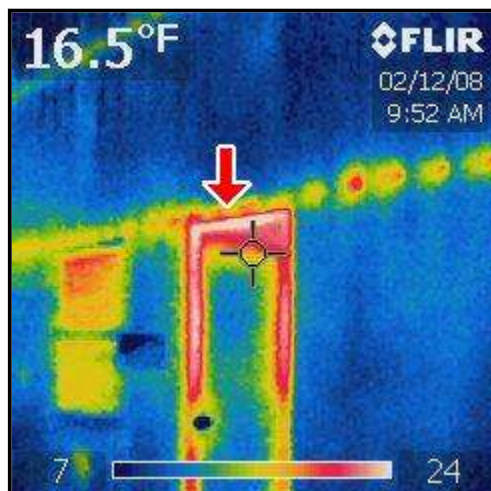
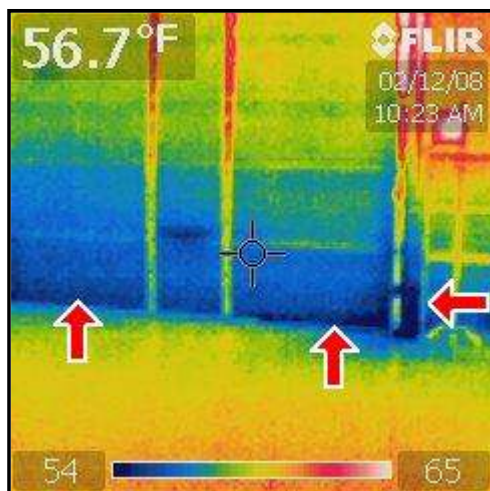
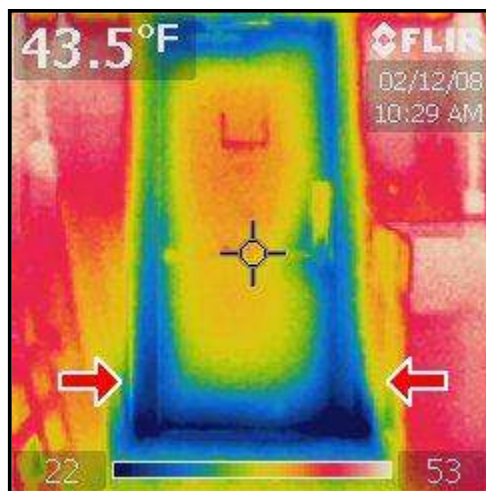
**2.1** The steel doors and overhead warehouse doors are not insulated well and are a source of heat loss. I recommend upgrading these door to increase the heating efficiency of the building.

2.1 Picture 1 Upgrade entry door.

2.1 Picture 2 Upgrade overhead door.

2.1 Picture 3 Upgrade door.

2.1 Picture 4 Upgrade overhead door.

2.1 Picture 5 Heat loss through overhead door.

2.1 Picture 6 Heat loss through entry door. West side.

2.1 Picture 7 Heat loss through overhead door.

2.1 Picture 8 Heat loss around entry door.

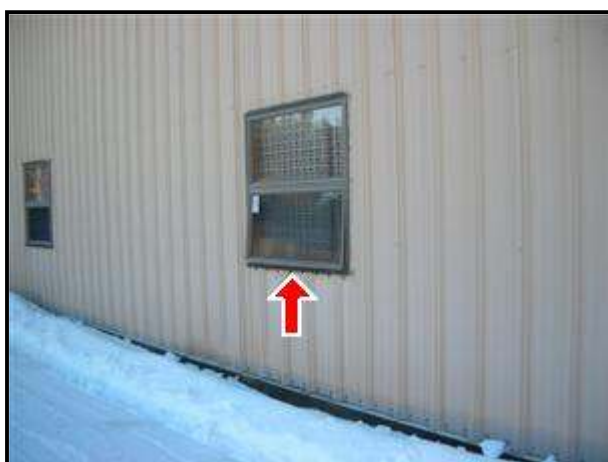
2.2 Picture 1 Window will not close.

**2.2** The windows in the building are original and although they are thermally insulated double pane glass their efficiency is low. I recommend upgrading the windows to improve the heating efficiency of the building.

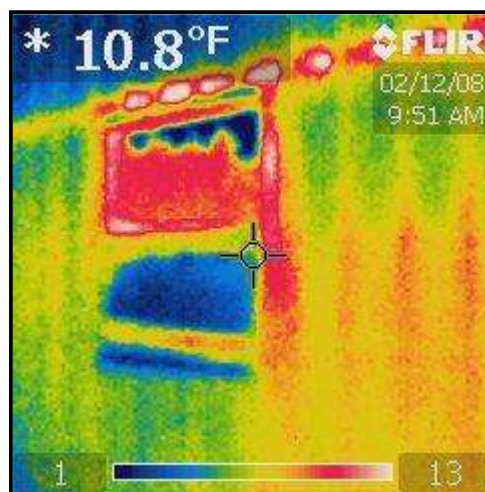
2.2 Picture 2 Heat loss around window.

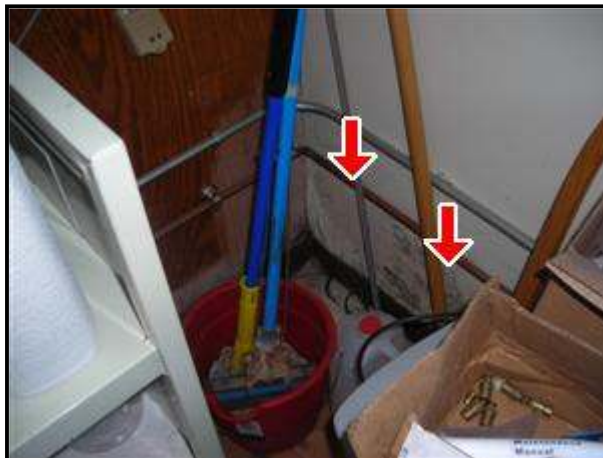
**5.1** Water penetration was observed in the office area adjacent from where the is moisture behind the siding. Once the siding is corrected this should stop. The drywall and insulation in this area should be removed and replaced after the siding is repaired.

5.1 Picture 1 Moisture penetration.

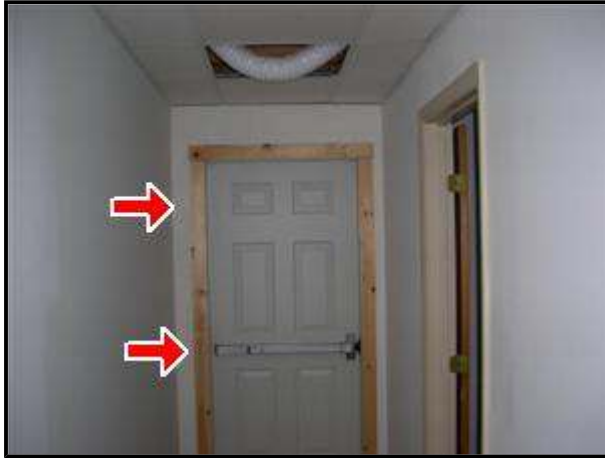
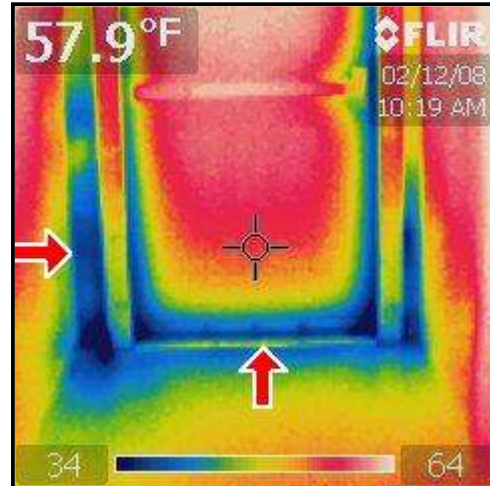
**5.3** As stated in the exterior section of the report most of the doors are not insulated and heat loss/cold air infiltration was observed. I recommend upgrading these doors to improve the

5.3 Picture 1 Cold air/heat loss.

5.3 Picture 2 Cold air/heat loss.

heating efficiency of the building.

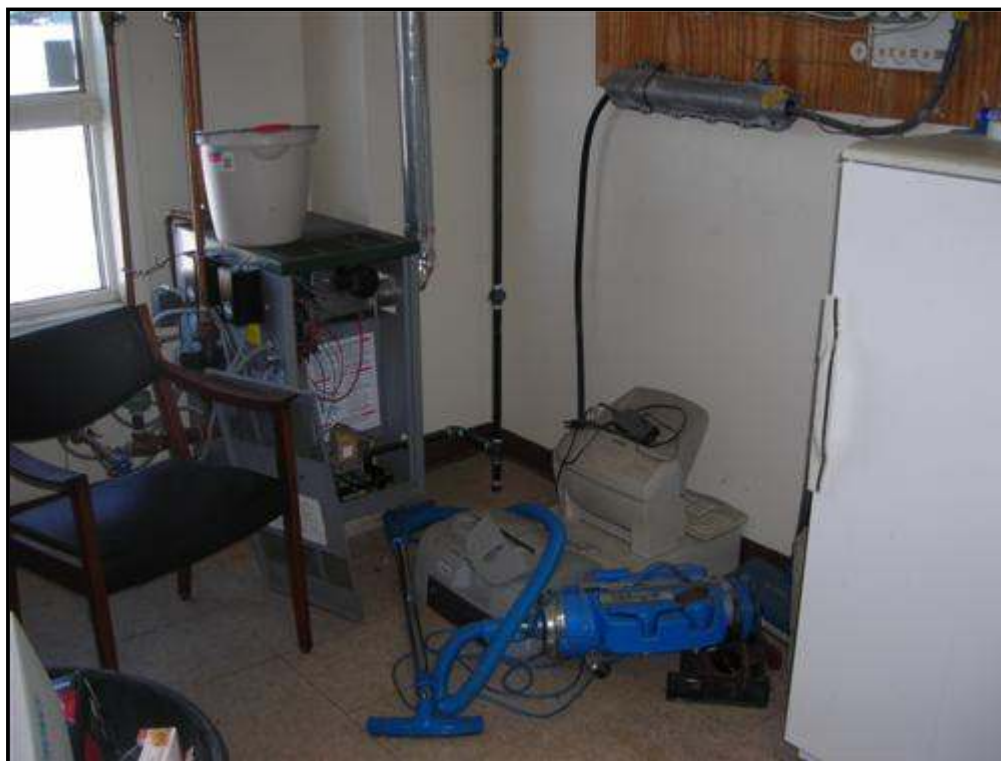
**8.0** The forced hot air system does not appear to have been serviced in quite some time. I recommend a licensed gas heating technician clean and fully evaluate this system.

8.0 Picture 1 Service heating system.
